# Flood Documentation Report

June 12, 2015 Flood Event  
Cherry Hills Village, Colorado

Issued July 15, 2015; Finalized January 5, 2016

*ICON Engineering, Inc.*

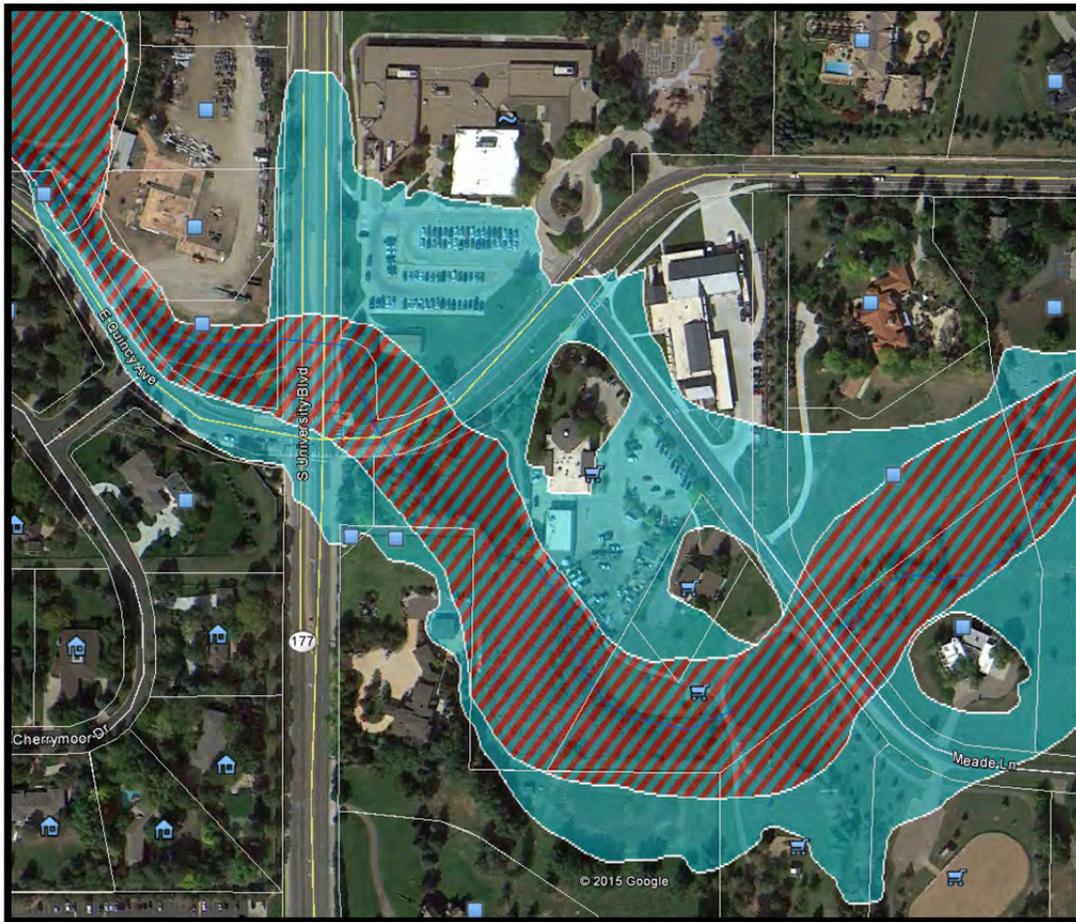
Greenwood Gulch is a different story. Unfortunately, flow data is not available. But, the lateral extent of the flooding largely followed the delineation and depths shown on the FEMA Flood Insurance Rate Map (FIRM). There are differences, but those are attributable to the variables considered in the FEMA mapping. Free flow conditions are assumed in the FEMA floodplain analyses, debris accumulation on structures and other floatable debris impacts are not accounted in the modeling. However, every flood has some level of debris accumulated in the flood flows.

**Figure: The Greenwood Gulch flood event was similar to the flood hazard area map**

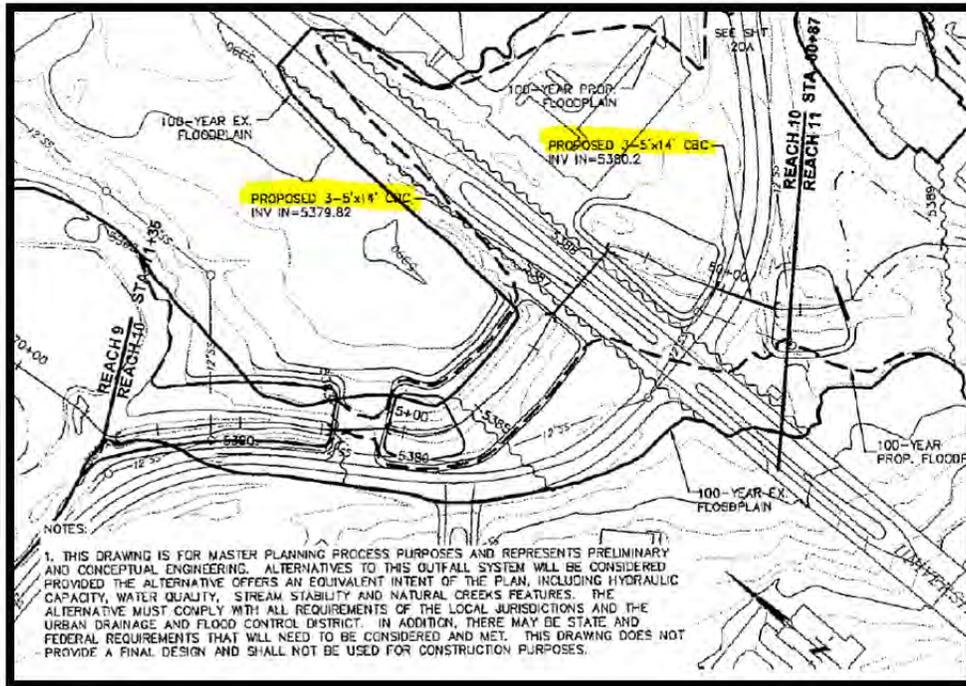
**Figure: UDFCD Little Dry Creek Masterplan Improvements on Greenwood Gulch**

The masterplan calls for additional culvert capacity under University Blvd and Quincy Ave. The proposed culverts are significantly larger than the multiple 30-inch diameter metal culverts that were superseded by the June 12<sup>th</sup> flood flows. The proposed mitigation work calls for triple 14-foot wide by 5-foot tall concrete box culverts under University and the same under Quincy Avenue.

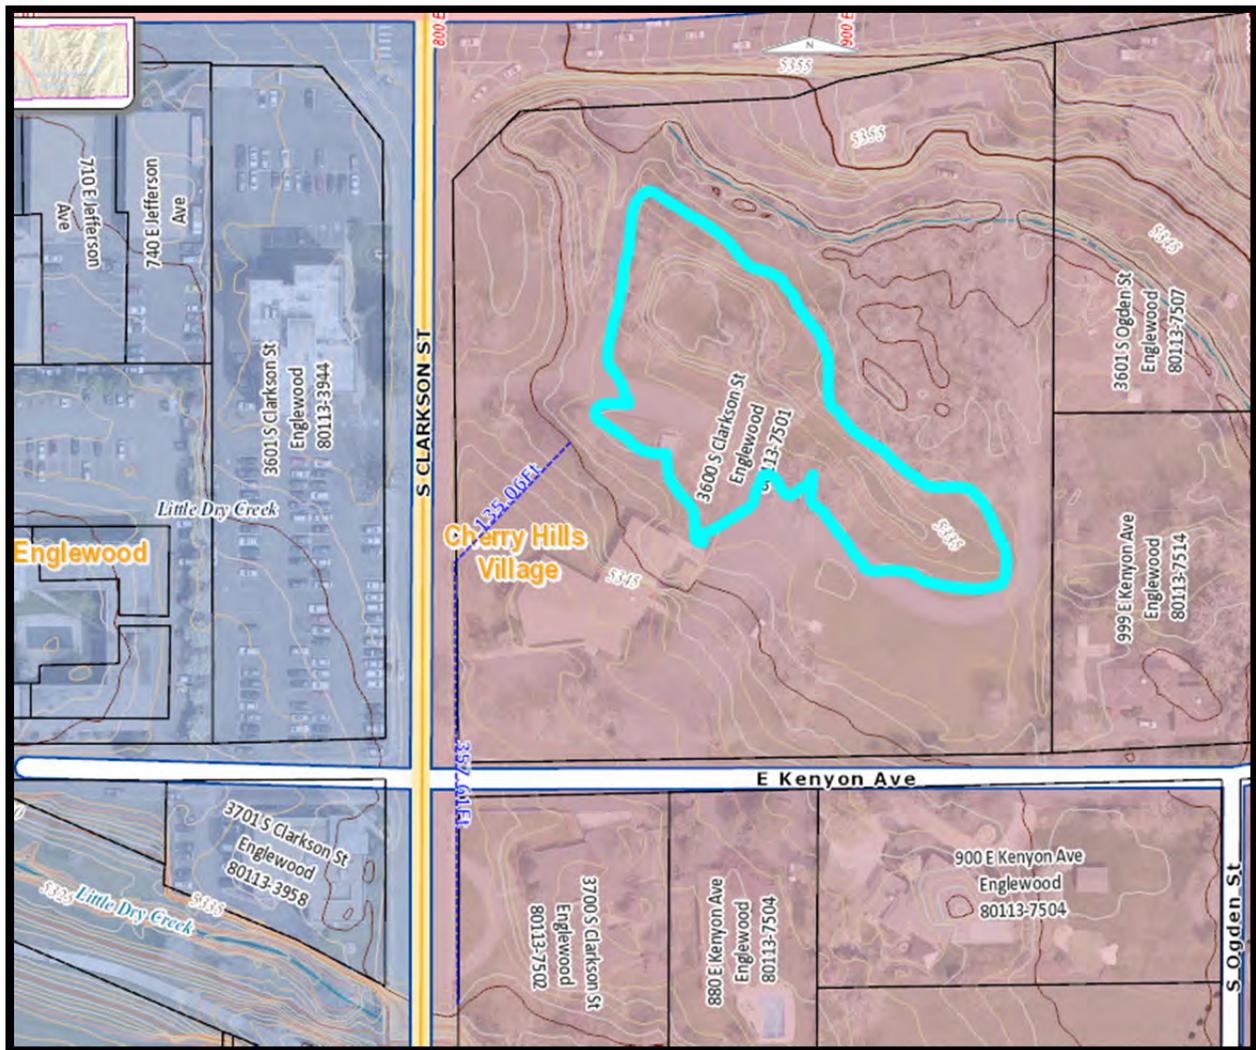
**Figure: Approximate elevations at the church property tying into existing storm inlets**

The drain would leave a residual ponding in the church property. To completely eliminate ponding during large storm events, the lowest grades of the property could be filled. A floodplain development permit would be required to prove the fill has no adverse impact on adjacent properties and insurable structures. Alternatively, a much deeper storm sewer could be connected through the lowest contours of the church property. To get this deep pipe to drain to Little Dry Creek, a tremendously deep excavation crossing dozens of existing utilities in and around Clarkson Street, would be required to drain into Little Dry Creek. A trenchless installation using underground boring and tunneling techniques would likely be more feasible, but just as expensive.

There are many factors that can affect the viability of this solution; existing dry utilities are the most notable obstacle to any retrofit gravity flow storm sewer installation. If existing utilities have already occupied the right-of-way or adjacent private property, the proposed storm sewer extension would have to avoid the conflicting utilities or pay for their relocation. However, if the proposed storm sewer can follow the existing storm sewer alignment with a slight upsizing of the pipe diameter, the solution may be reasonably straight forward storm sewer installation work.
